This spreadsheet performs screening level calculations to estimate the effect of peeling leaded paint on the average concentration of lead in yard soil  
4957 Clayton St.

## LBP Assessment Results

Property ID # 2576 / 4957 Clayton Street

SITE NAME: VASQUEZ BLVD AND I-70

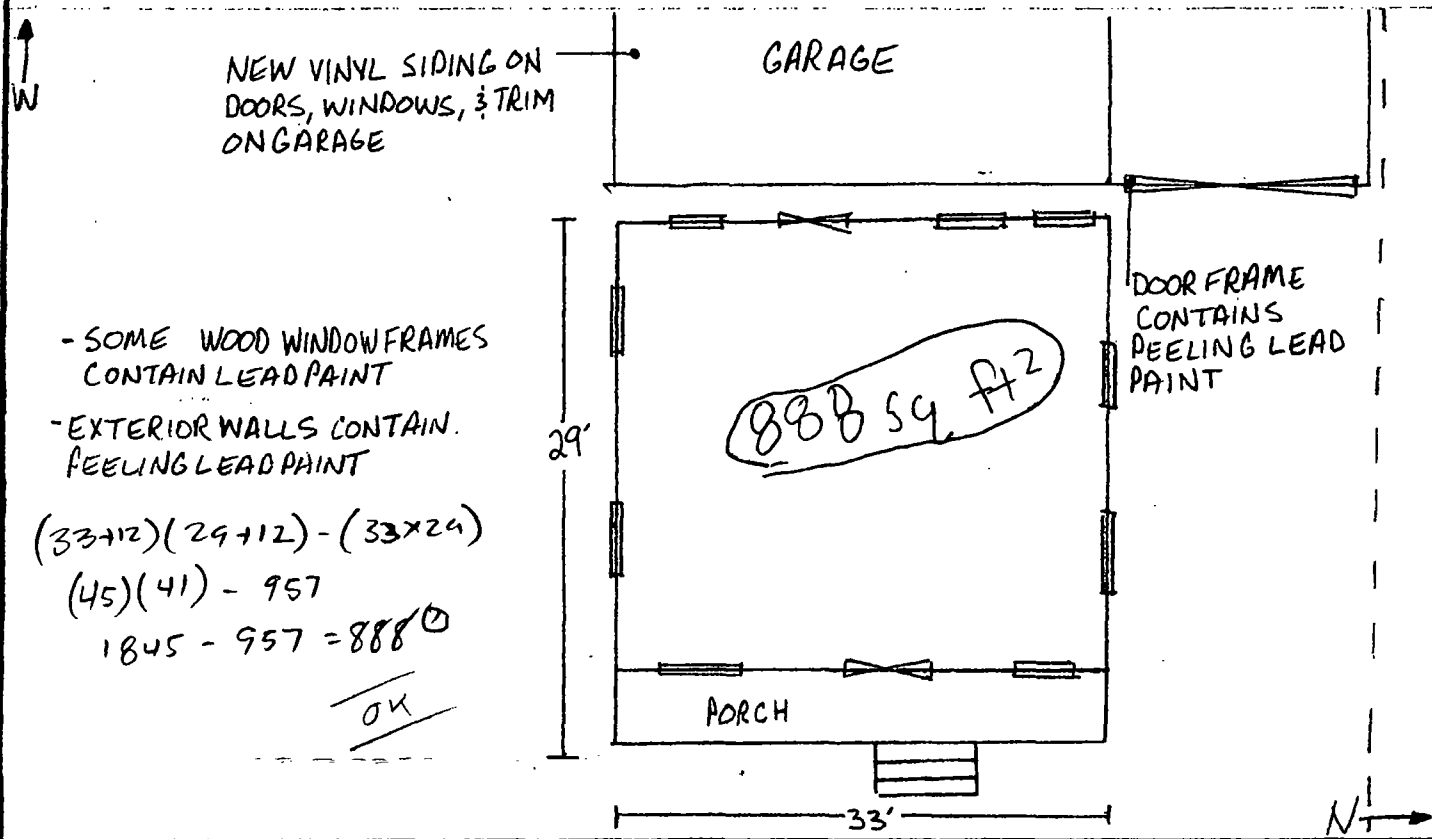
Exterior Walls				Doors/Trim			
	Material	Area	Peel/Chip	XRF (Lead)	Material	Area	Peel/Chip	XRF (Lead)
North	WOOD	290'±	PEEL	2.6	WOOD	—	—	1.7
South	WOOD	290'±	PEEL	2.0				
East	WOOD	—	—	1.9	WOOD	—	CRACK	2.0
West	WOOD	330'±	PEEL	1.8				
	Total				Total

Window Trim/Paschia/Soffit				Patios/Decks/Porches			
	Material	Area	Peel/Chip	XRF (Lead)	Material	Area	Peel/Chip	XRF (Lead)
North	WOOD	4'±	PEEL	2.3				
South	WOOD	—	—	—				
East	WOOD	—	CRACK	2.0	CONCRETE	—	—	—
West	WOOD	—	—	—				
	Total				Total

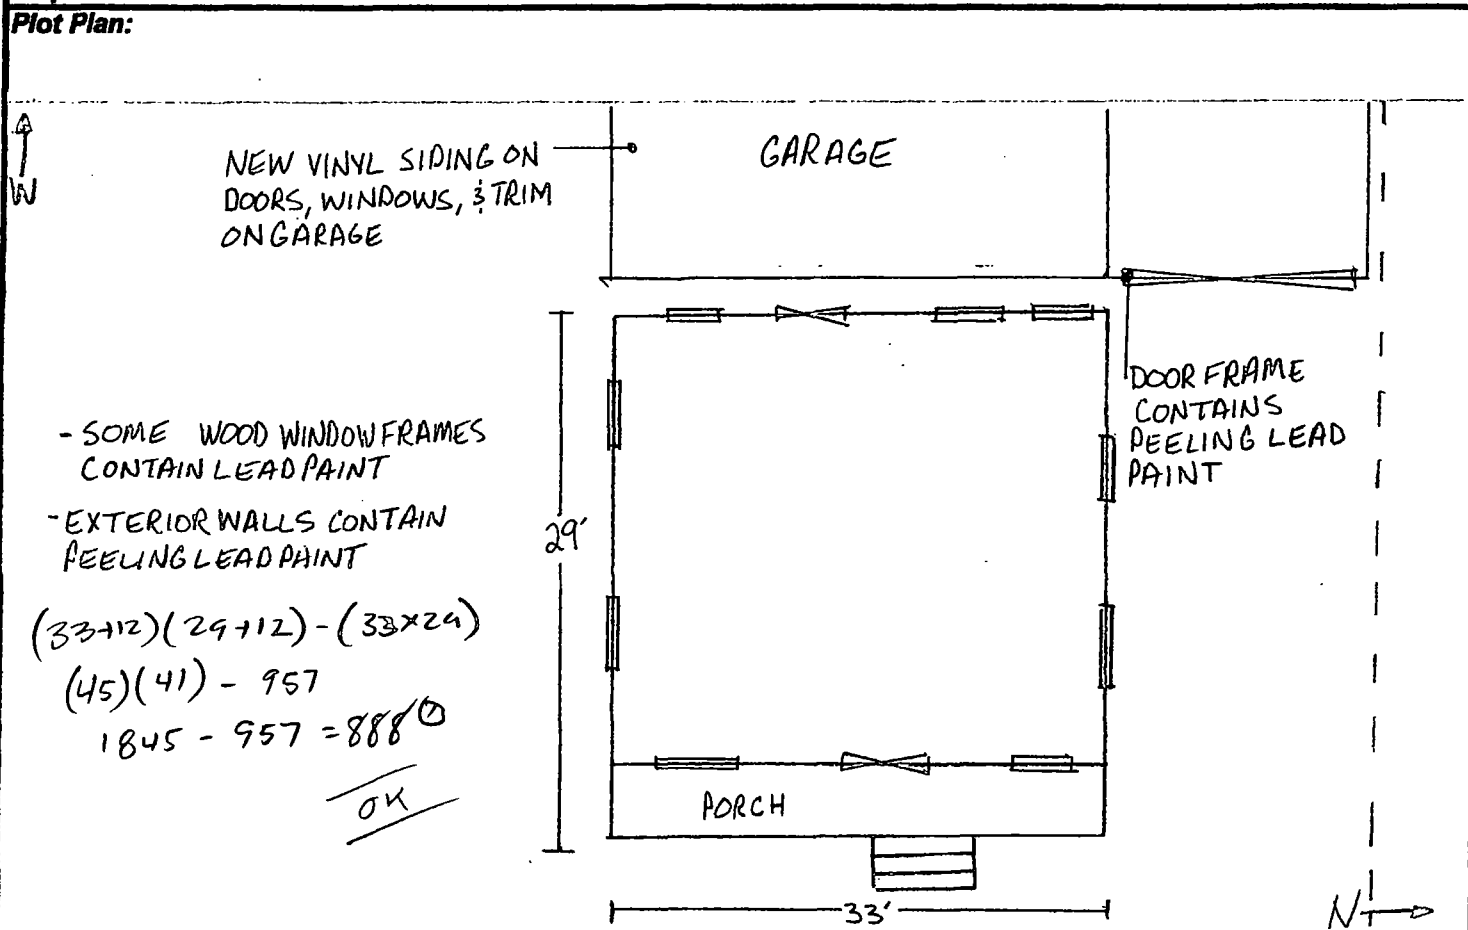
Exterior Walls				Doors/Trim				
Material	Area	Peel/Chip	XRF (Lead)	Material	Area	Peel/Chip	XRF (Lead)	
North	WOOD	290'±	PEEL	2.6	WOOD	—	—	1.7
South	WOOD	290'±	PEEL	2.0				
East	WOOD	—	—	1.9	WOOD	—	CRACK	2.0
West	WOOD	330'±	PEEL	1.8				
Total				Total

Window Trim/Fascia/Soffit				Patios/Decks/Porches			
Material	Area	Peel/Chip	XRF (Lead)	Material	Area	Peel/Chip	XRF (Lead)
North	WOOD	4'±	PEEL	2.3			
South	WOOD	—	—				
East	WOOD	—	CRACK	2.6	CONCRETE	—	—
West	WOOD	—	—				
Total				Total
